Near-surface mounted carbon fibre rod used for combined strengthening and cathodic protection for reinforced concrete structures

The dual function of a carbon fibre reinforced polymer (CFRP) rod working as the near surface mounted (NSM) strengthening and impressed current cathodic protection (ICCP) anode for corroded reinforced concrete structures has been proposed and researched. In this paper, a CFRP rod was used for both flexural strengthening of pre-corroded reinforced concrete beams and in a dual functional capacity as an ICCP anode. After a period of ICCP operation at high current density, the beams were subjected to flexural testing to determine the load-deflection relationships. The potential decays of the steel met recognised ICCP standards and the CFRP remained effective in strengthening the corroded reinforced concrete beams. The bonding at the CFRP rod anode and concrete interface was improved by using a combination of geopolymer and epoxy resin, therefore the ultimate strength of a dual function CFRP rod with combination of bonding medium (geopolymer and epoxy) increased significantly.

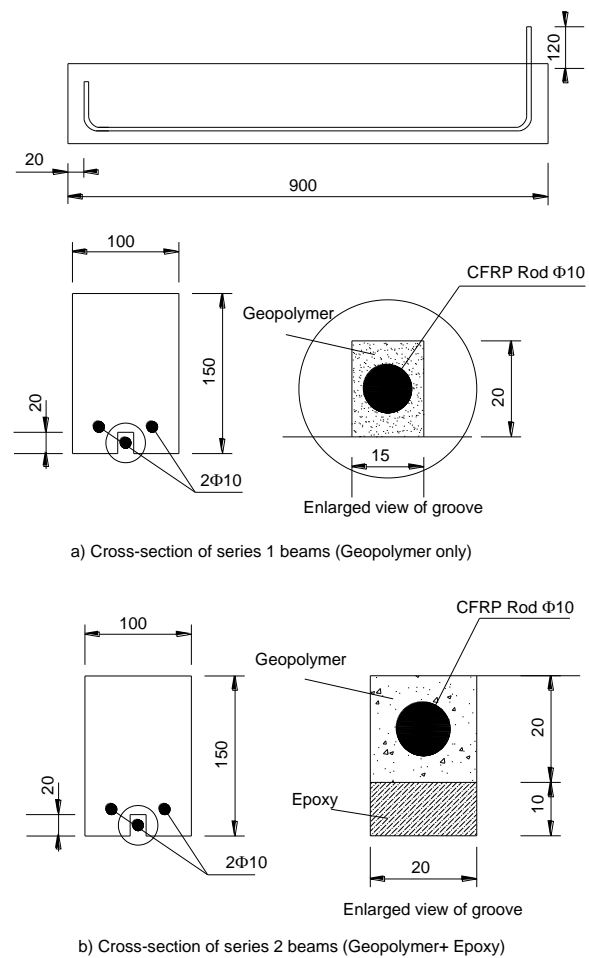
Figure 1. Detailed dimensions of beam specimens

plain steel bars of 10 mm diameter. There was no shear reinforcement (Figure 1). This was aimed to avoid any effects of shear steel bars in accelerating corrosion of longitudinal reinforcement. All beams were designed for flexural failures; therefore, premature shear failure was prevented through the use of external steel collars during flexural testing. Each steel collar included 2 mild steel plates each dimensions of 210 x 200x 10 (mm) and 2 mild steel plates each dimensions of 270x 150x 10 (mm). Details of the steel collars are shown in Figure 2. The dimensions of the groove in Figure 1 were selected in accordance with ACI 440.2R-08 (2008) “Guide for the design and construction of externally bonded FRP systems for strengthening concrete structures” (American Concrete Institute, 2008).

The first group using CFRP rod utilised a pre-formed groove on the tension soffit of the concrete beams using geopolymer only (Figure 1a). The groove was half filled with the geopolymer, the CFRP rod was placed inside the groove and further geopolymer was added to completely fill the groove (see Figure 4).

For the second group, the CFRP rod was bonded to the pre-cut groove by two layers of repair material. A schematic of repair is shown in Figure 1b. Firstly, the CFRP rods were bonded into the grooves by geopolymer (Figure 5a). The geopolymer repair was cured in the ambient laboratory conditions for 7 days at which time epoxy was overlaid as the second repair material (Figure 5b). The purpose of the epoxy layer was to improve the bond between the CFRP rod anode and repair material. This is the difference between Groups 1 and 2 and should have some influence on the improvement in strength capacity due to the greater elasticity of the epoxy compared to the brittle nature of the geopolymer at the zone of greatest tensile stress. These samples were cured in the laboratory environment for a further 21 days prior to ICCP application.

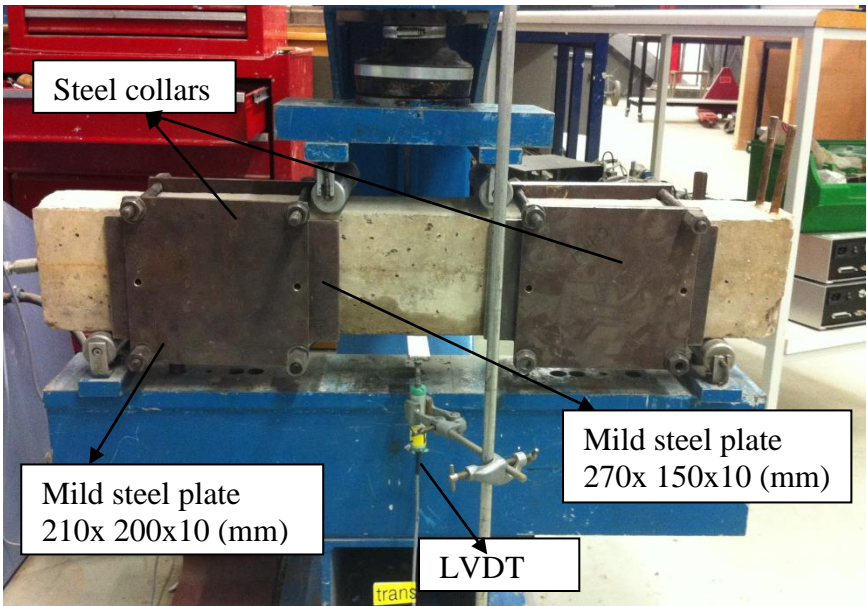
Figure 2. Four point bending test of beams and detailed steel collars

All beams were tested under four point bending (see Figure 2). Load measurements were taken by means of a 3000kN load cell connected to a signal amplifier with low pass filter which in turn was connected to a load cell power supply and digital balancing and monitoring unit. The amplifier was calibrated to ensure a direct reading of the applied load on the digital monitoring unit, with an accuracy of 0.1kN. The loading rate was 5KN/min.

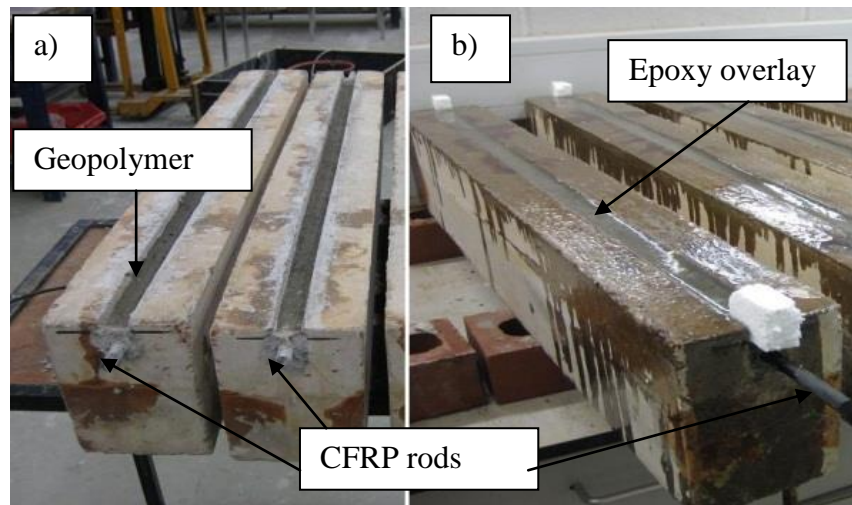
Figure 5. (a). Bonding CFRP rods to pre-grooved beams by geopolymer (first layer of repair material) (b). Overlay of epoxy as the second layer of repair

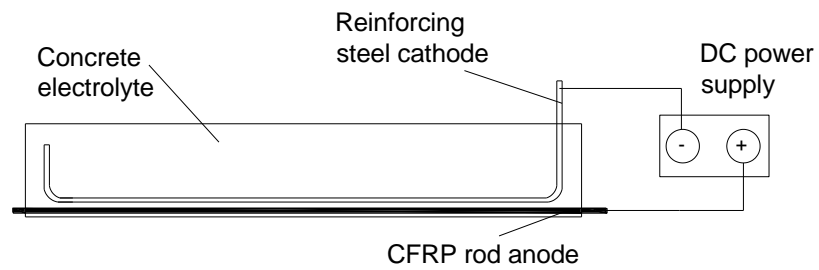
Figure 6. Schematic ICCP application to corroded reinforced concrete beams

ICCP was applied to the corroded reinforced concrete beams by connecting the reinforcing steel to the negative terminal and the CFRPs anode to the positive

terminal of a multi-channel power supply. The schematic of ICCP application is shown in Figure 6. The system was cathodically protected at room temperature (nominally 20°C) and 60% relative humidity (plus or minus 5%). These conditions ensured the resistivity of the concrete remained high, representing a dry site environment. The applied current densities were 64.2mA/m² of steel surface area for Beams 1.5 and 1.6 (Group 1-Table 1) and were varied between 125mA/m² and 310mA/m² of steel surface area for Beams 2.5 and 2.6 (Group 2-Table 1). The current was checked and the on and instant -off potentials of the embedded steel were recorded daily.

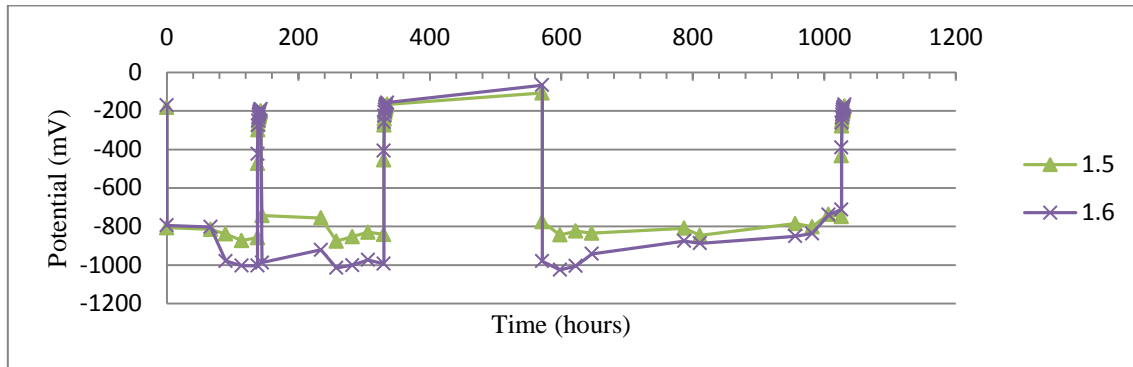
Figure 7. Potential (vs Ag/AgCl/0.5M KCl) of steels during operation of ICCP - Beams 1.5 and 1.6 (constant current density of 64.2mA/m^2 of steel area)

During the 1026 hours (corresponding to approximately 43 days) of operation of ICCP (Figure 7), the on- potential and potential decays of steel bars were recorded using embedded Ag/AgCl/0.5M KCl reference electrodes and a high impedance digital voltmeter (DVM). The ICCP was interrupted three times at 138 hours, 330 hours and 1026 hours, respectively. Although ICCP was achieved at each interruption (138 and 330 hours) the ICCP was re-run again to investigate the long term performance of dual function CFRP rod. At 330 hours, the ICCP was interrupted for 241 hours before it was restarted at 571 hours and continued to 1026 hours. The potential decays at these three occasions were monitored and are shown in Table 2.

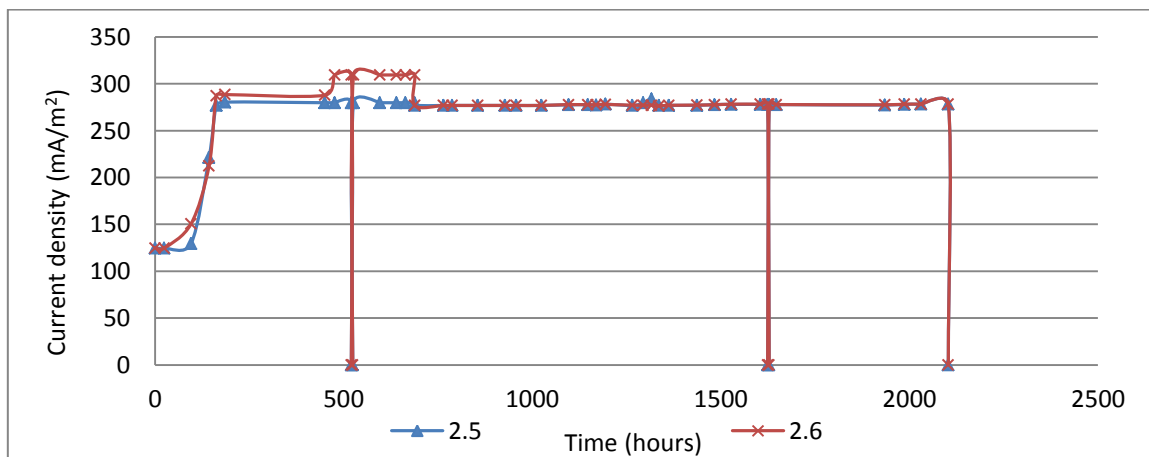
Figure 8. ICCP applied current densities (mA/m^2 of steel surface area)- Beams 2.5 and 2.6

The applied currents to Beams 2.5 and 2.6 were recorded and plotted in Figure 8. The applied current densities for both beams were around 125mA/m² for

approximately 100 hours before this was increased to around 280mA/m^2 to ensure adequate polarisation of the steel. The potential drop defined as difference between instant- off potential and rest potential should be greater than 150mV (The Concrete Society 2012). However, there was a small increase in current density applied to Beam 2.6 for a period of about 200 hours. The current density applied to Beam 2.6 was increased to around 310mA/m^2 at approximately 470 hours and reduced again to 280mA/m^2 at 688 hours. These adjustments of current densities were based on the polarisation of the steel. It also aimed to reduce the risk of any possible negative effect of too high a current on the bond at the CFRP rod/geopolymer interface.

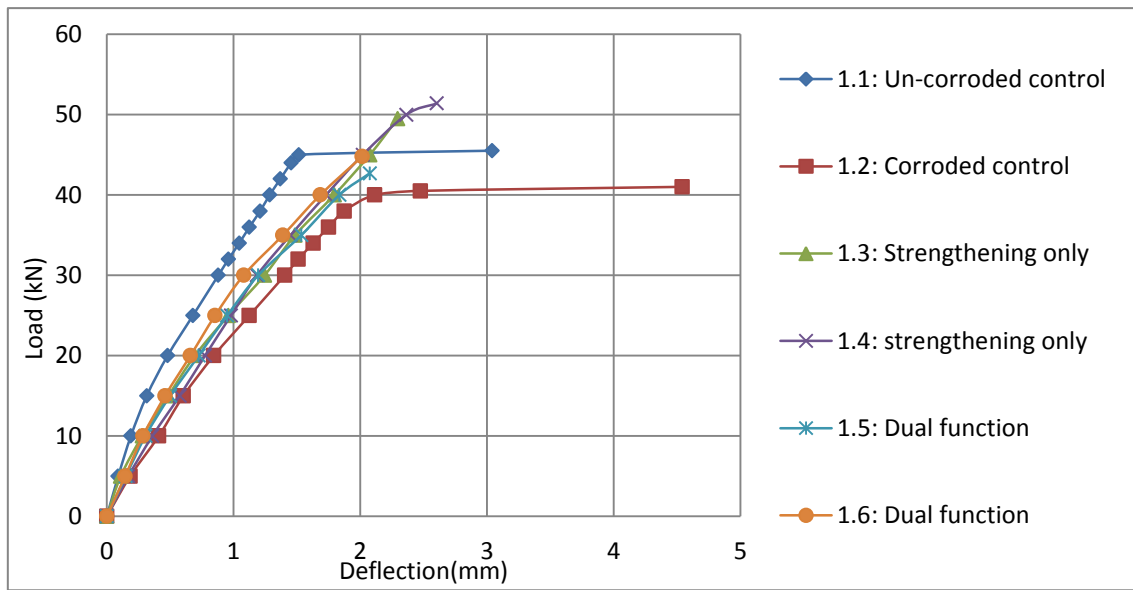
Figure 10. Load deflection curves of Group 1 beams- geopolymer only

The load- deflection relationships of Group 1 beams are shown in Figure 10. While the ultimate strength of corroded control Beam 1.2 (41.0kN) reduced compared to the un-corroded control Beam 1.1 (45.5kN), the deflection at failure of Beam 1.2 (4.54mm) increased compared to Beam 1.1 (3.04mm). This was due to the influence of steel reinforcement corrosion on the stiffness of beam. Previous research (O'Flaherty, et al 2010) shows that reinforced concrete beams show a loss in stiffness with increasing corrosion of the main steel reinforcement and as the result the stiffness of corroded Beam 1.2 reduced.

The mean ultimate strength of the CFRP rod strengthened beams (1.3 and 1.4) was approximately 23% greater than the ultimate strength of un-strengthened

Beam 1.2 (Table 3). Beams 1.3 and 1.4 both failed due to the debonding of the CFRP rod (Figure 11). The average ultimate deflection of Beams 1.3 and 1.4 (2.45mm) was reduced by 46% compared with the ultimate deflection of Beam 1.2 (4.54mm) (Table 3). This was attributed to the CFRP rod application to Beams 1.3 and 1.4 leading to an increase in their stiffness compared to Beam 1.2.

Beams 1.5 and 1.6 used the CFRP rod for the dual function of strengthening and ICCP anode. Comparing the results with the un-strengthened Beam 1.2, the mean ultimate strength of the beams with the dual function CFRP rod (Beams 1.5 and 1.6) increased by 6.7%. Again, Beams 1.5 and 1.6 both failed due to debonding of the CFRP rod anode. The mean ultimate deflection of Beams 1.5 and 1.6 (2.05mm) was approximately 55% less than the ultimate deflection of Beam 1.2 (4.54mm) (see Table 3). Again, this was attributed to the CFRP rod application to Beams 1.5 and 1.6 leading to an increase in their stiffness compared to Beam 1.2.

The mean ultimate strength of Beams 1.5 and 1.6 (43.75kN) in which CFRP rods were used as ICCP anodes was reduced by about 13%, compared with the mean ultimate strength of Beams 1.3 and 1.4 (50.45kN) in which CFRP rods were used for strengthening only (Table 3). This is considered likely to be due to the application of ICCP adversely affecting the bonding at the CFRP rod /geopolymer interface or geopolymer/concrete interface. The average ultimate deflection of Beams 1.5 and 1.6 (2.05mm) was 16% less than the average ultimate deflection of Beams 1.3 and 1.4 (2.45mm) (see Table 3).

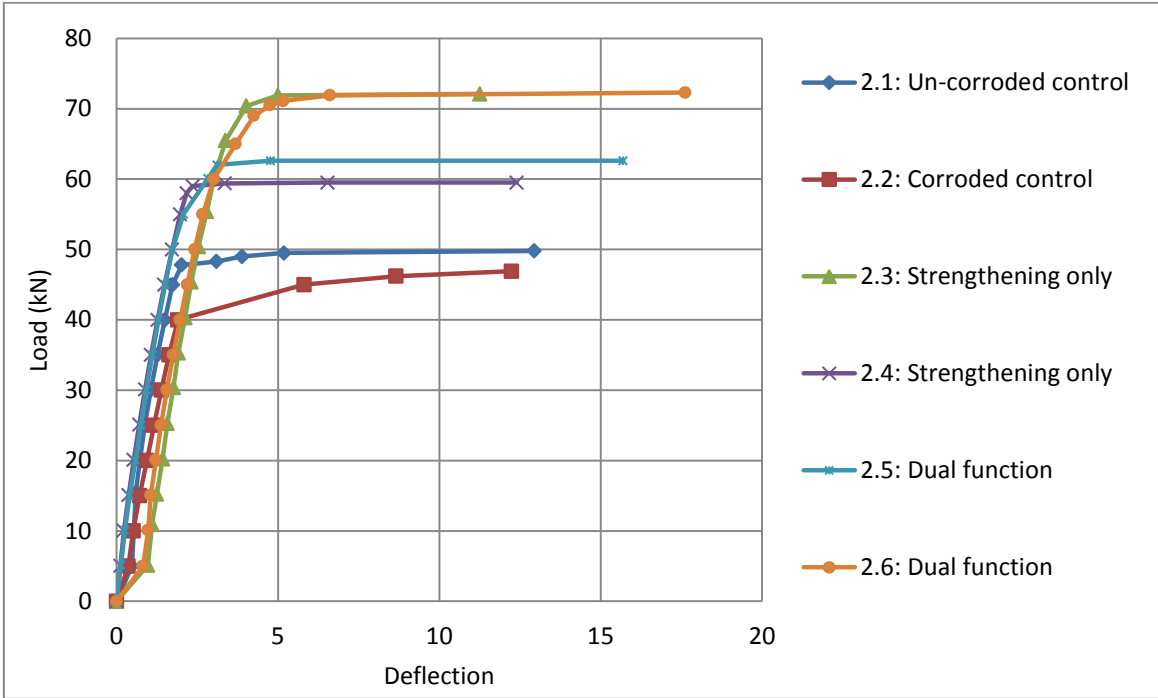
Figure 12. Load-deflection curves of Group 2 beams- combination of geopolymer and epoxy

The load-deflection relationships of Group 2 are plotted in Figure 12. While the ultimate strength of corroded control Beam 2.2 (46.9kN) reduced

compared to the un-corroded control Beam 1.1 (49.8kN), the deflection at failure of Beam 2.2 (8.68mm) increased compared to Beam 1.1 (5.18mm). Similar to Group 1, this was due to the influence of steel reinforcement corrosion on the stiffness of beam as stated previously.

The mean ultimate strength of the CFRP rod strengthened beams without CP (2.3 and 2.4) is 40.3% higher than the equivalent value for the un-strengthened Beam 2.2. The mean ultimate strength of the dual function beams (CFRP rod strengthening and CP) (Beams 2.5 and 2.6) is 43.81% higher than Beam 2.2 (see Table 3). The ultimate strength of the dual function beams is marginally higher than that of beams with strengthening only. In Group 2 beams, the effect of the ICCP current on the bond strength at the CFRP rod and repair material interface is very small when utilising the combination of geopolymer and epoxy.

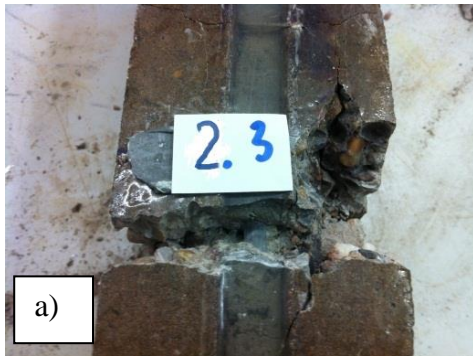
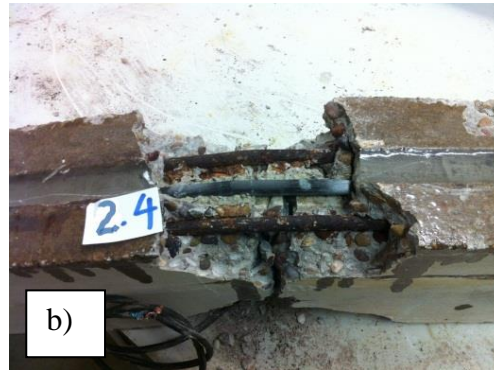
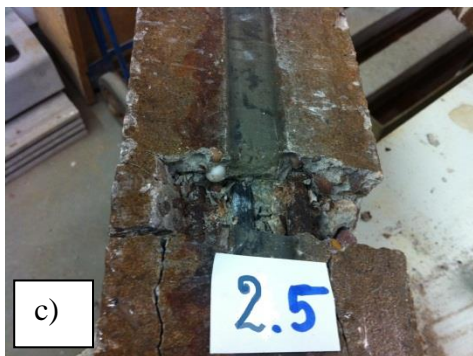
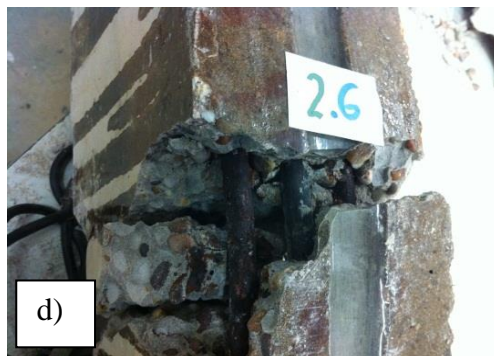
Figure 13. Failed beams

- a) Failure of strengthening only beam 2.3
- b) Failure of strengthening only beam 2.4
- c) Failure of dual function beam 2.5
- d) Failure of dual function beam 2.6

The failure modes of four strengthened beams were recorded and shown in Figures 13a to 13d. Flexural failure of Beam 2.3 (Figure 13a) started by the yielding of steel reinforcement followed by the rupture of second layer repair material (epoxy) and debonding at the CFRP rod/geopolymer interface. Post-bending investigation was conducted at the flexural failure section. There was no debonding at the geopolymer/concrete interface or geopolymer/epoxy interface. The failure mode of Beam 2.4 (Figure 13b) was similar to Beam 2.3; however, it was observed that the CFRP rod had a crack across the cross-section. The flexural failure of Beam 2.5 (Figure 13c) started by the yielding of the reinforcing steel, followed by the rupture of the epoxy layer. There was debonding at the CFRP rod/geopolymer interface, however, there was no debonding at the geopolymer/epoxy interface. Further examination revealed that there was minor debonding at the geopolymer/concrete substrate interface, due to inadequate cover to the CFRP rod provided by the geopolymer layer.

The failure mode of Beam 2.6 (Figure 13d) was more complicated. After yielding of the steel bars, the epoxy layer was ruptured following the formation of longitudinal cracks in the CFRP rod. Post-bending test investigation revealed that there was no debonding at the geopolymer/concrete or geopolymer/epoxy interfaces, however there was debonding at the CFRP rod/geopolymer interface. The CFRP rod had slipped, which is attributed to a loss of bond at the CFRP rod/geopolymer interface.

From the detailed examination of the four CFRP rod strengthened beams, debonding was only observed at the CFRP rod/geopolymer interface. In comparison with the NSM technique using geopolymer only as the repair material in Group 1, there is an improvement in the bonding between the CFRP rod and repair materials, and therefore the capacity of strengthening is increased significantly.
